Chapter 7—Environmental Barriers

Chapter 7: Environmental Barriers

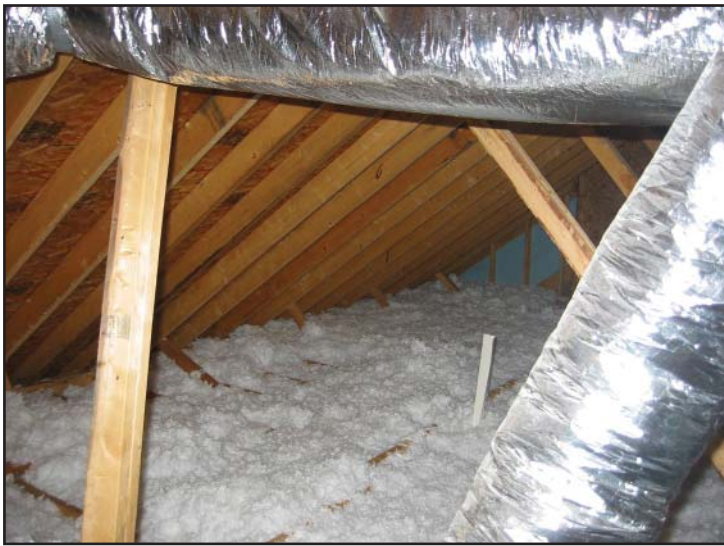
Figure 7.2. Blown Attic Insulation

A house must be able to breathe; therefore, air must not be trapped inside, but must be allowed to exit the home with its moisture. Moisture buildup in the home will lead to both mold and bacteria growth. Figure 7.2 demonstrates insulation blown into an attic, to a depth of approximately 12 inches (Figure 7.3). Figure 7.4 shows the area extending from a house under the roof, known as the soffit. The soffit is perforated so that air can flow into the attic and up through the ridge vents to ventilate the attic.

If insulation is too thick or installed improperly, it restricts proper air turnover in the attic and moisture or extreme temperatures could result in mold or bacteria growth, as well as delamination of the plywood and particleboards and premature aging of the roof's subsurface and shingles.

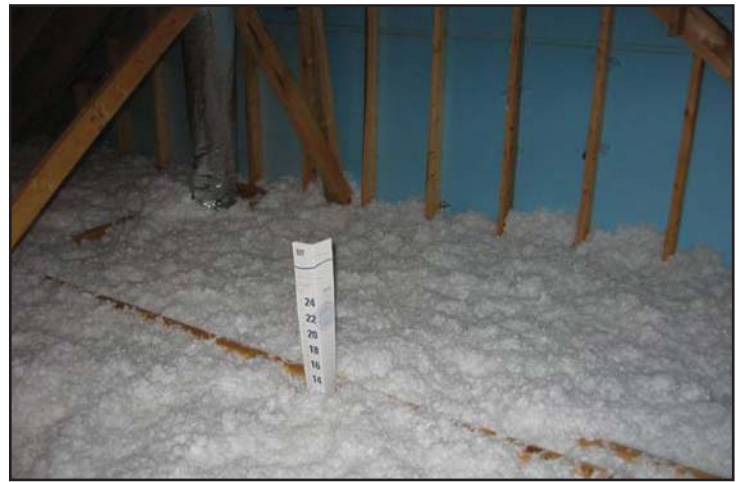
Figure 7.3. Depth of Attic Insulation

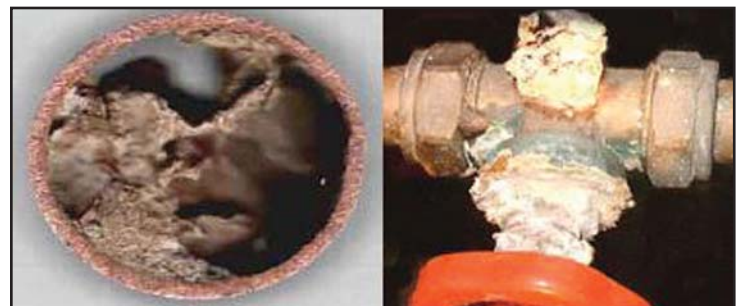
Figure 7.6. Corrosion in Piping Resulting From Galvanic Response

Figure 7.6 shows examples of electrochemical kinetics in pipes that were connected to dissimilar metals.

If metal siding is used, the mounting fasteners (nails or screws) must be compatible with the metal composition of the siding, or the siding or fasteners will corrode. This corrosion is due to galvanic response.

When two dissimilar metals, such as aluminum and steel, are coupled and subjected to a corrosive environment (such as air, water, salt spray, or cleaning solutions), the more active metal (aluminum) becomes an anode and corrodes through exfoliation or pitting. This can happen with plumbing, roofing, siding, gutters, metal venting, and heating and air conditioning systems.

When two metals are electrically connected to each other in a conductive environment, electrons flow from the more active metal to the less active because of the difference in the electrical potential, the so-called "driving force." When the most active metal (anode) supplies current, it will gradually dissolve into ions in the electrolyte and, at the same time, produce electrons, which the least active (cathode) will receive through the metallic connection with the anode. The result is that the cathode will be negatively polarized and hence be protected against corrosion.
